MNM Fatal 2014-03

- Falling/Sliding Material
- February 28, 2014 (New York)
- Sand & Gravel Mine
- Supervisor
- 50 years old
- 27 years of experience

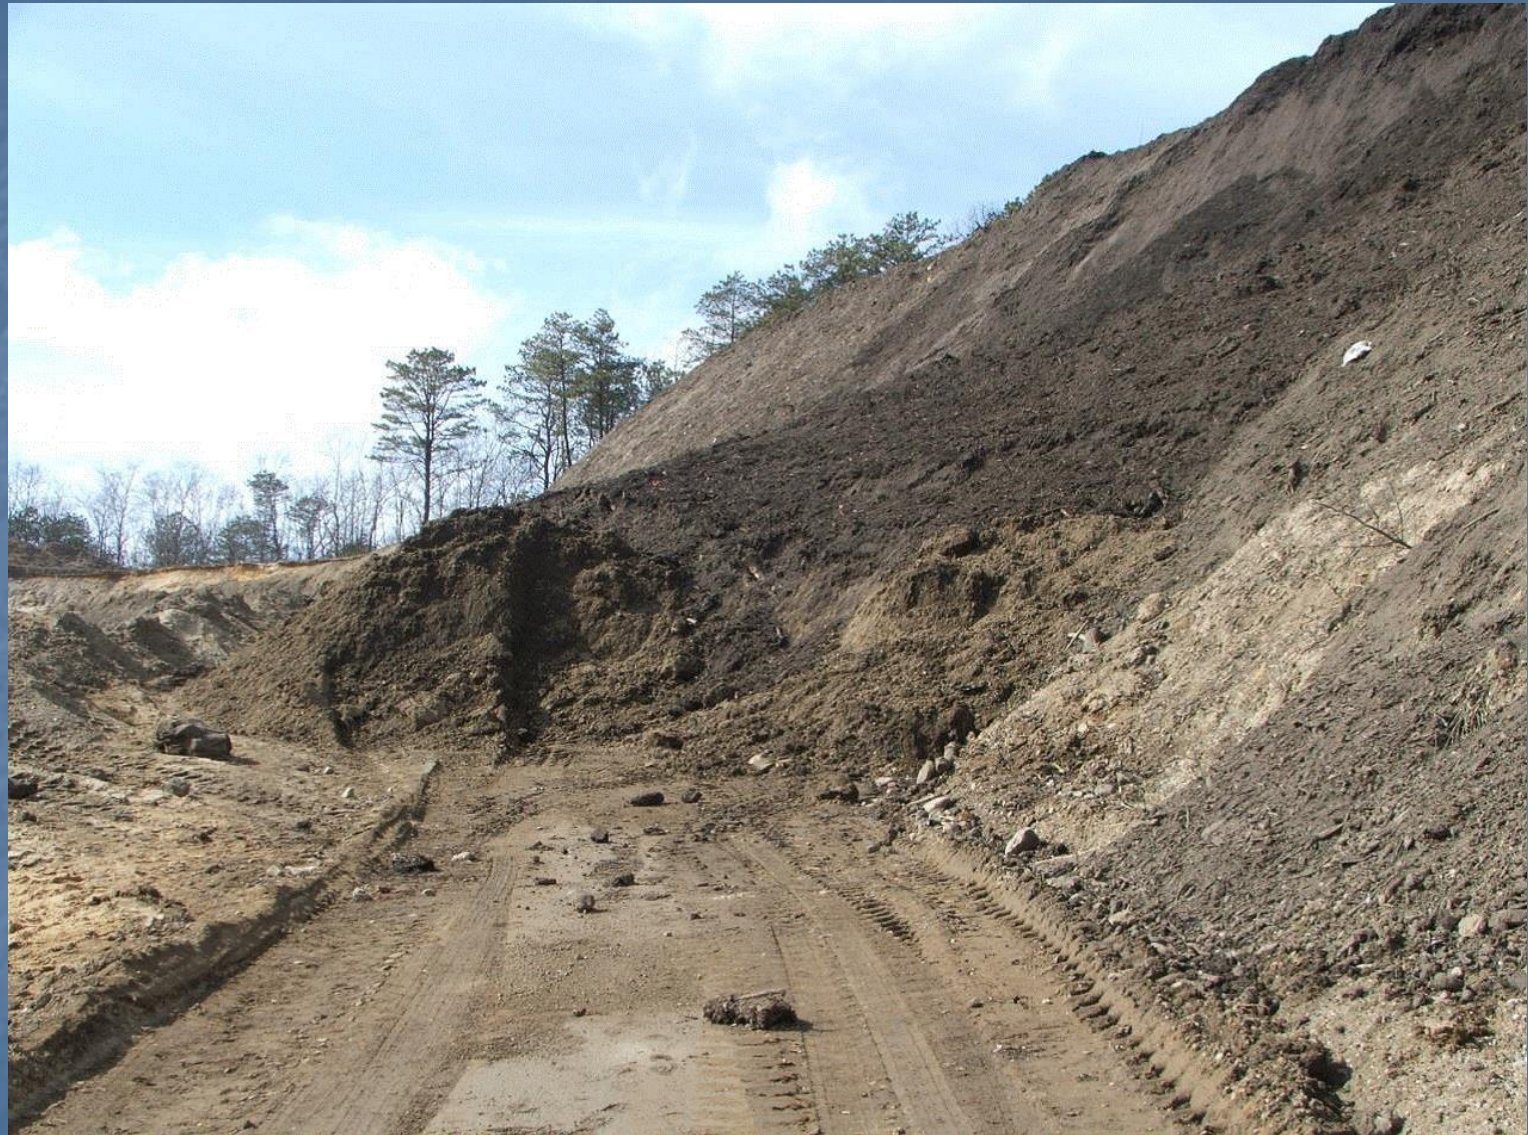
The victim was killed when went to the mine's reclamation dump site to investigate a report of smoke sighted at that area. He traveled to the site with another miner, parked his truck, and started to climb an embankment. When the victim climbed approximately 40 feet, the embankment failed and engulfed him.

The accident occurred due to the management's failure to establish methods to maintain the slope stability at the reclamation dump site where miners worked or traveled in performing their assigned tasks. The material being used to reclaim the area was a mixture of approximately 70 percent loam and 30 percent mulch. The moisture content, the frozen condition, and the fibrous nature of the loam/mulch mixture could have allowed the material to hold itself in a slightly over-steepened state. The material dumped on the day of the accident added an additional load and could have created a slope that was marginally stable. The relatively warm material (woody mulch) could have thawed the frozen mulch already in place. A combination of these factors caused a temporary reduction of shear strength within the reclamation material causing the marginally stable slope to fail.

Root Cause: Management failed to establish methods to maintain the slope stability at the reclamation dump site where miners worked or traveled in performing their assigned tasks. The approximately 80-foot high embankment failed and engulfed the victim.

Corrective Action: Management modified the reclamation plan at the mine to include using additional material fill to form a flatter slope which can be maintained using a dozer. In addition, management abandoned the lower access road by permanently blocking the east and west approaches to the roadway. These revisions eliminate the need for persons to travel near the base of the slope.
